# Boston's Open Space

1987  
PARK EVALUATION  
&  
SITE SUMMARIES

EVALUATION OF  
CITY OF BOSTON  
PARK AND RECREATION LAND

NEIGHBORHOOD OF BACK BAY/BEACON HILL

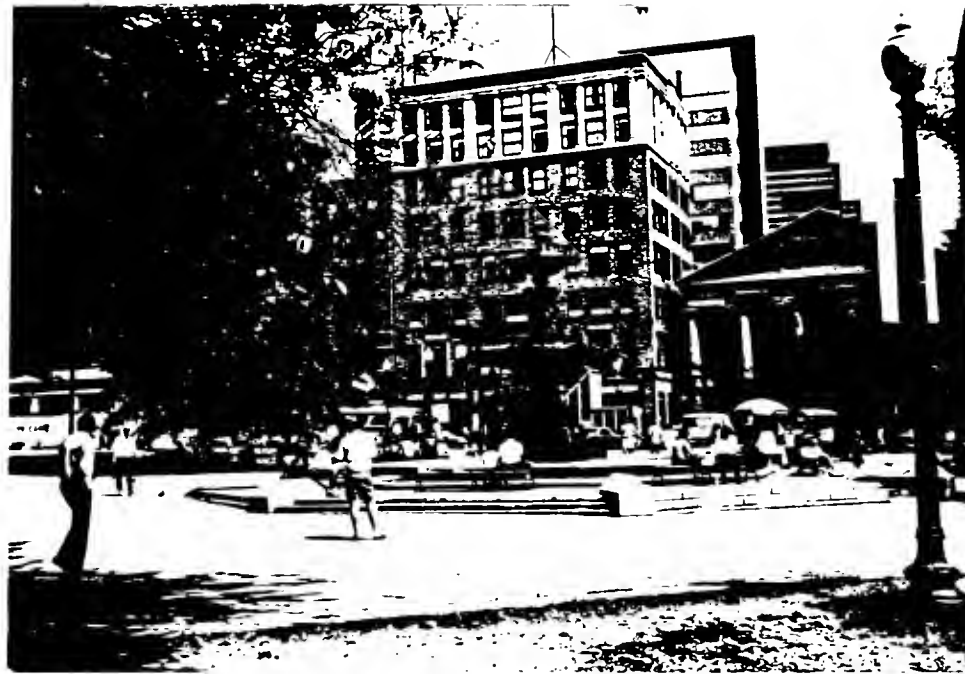
### Site Photograph 4

Fountain and public use area.

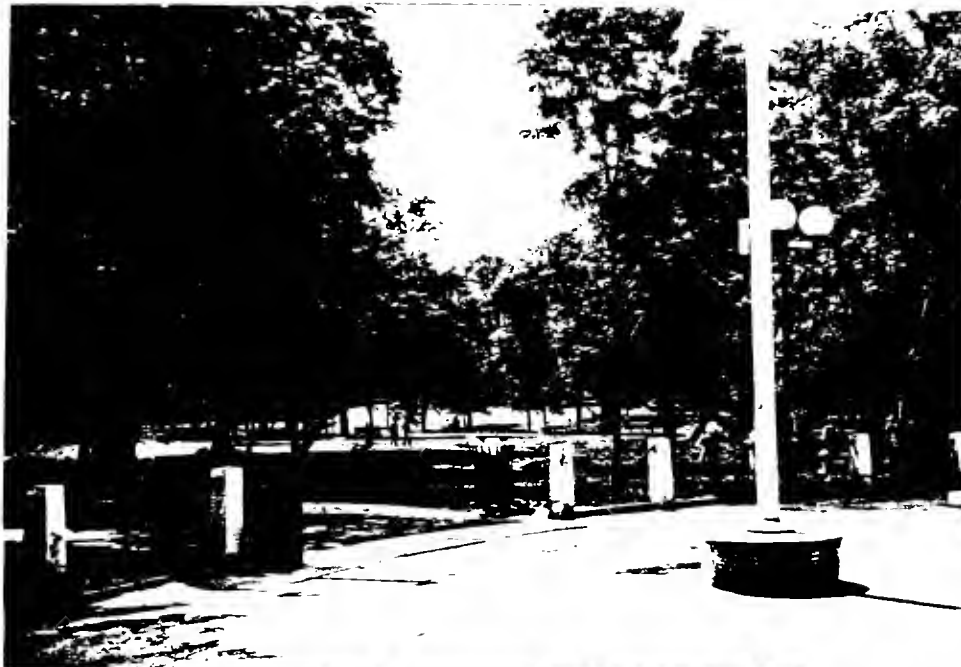
### Site Photograph 7

Granite bollards and chain-- an effective edging around flag pole area. Light fixtures out of character with park.

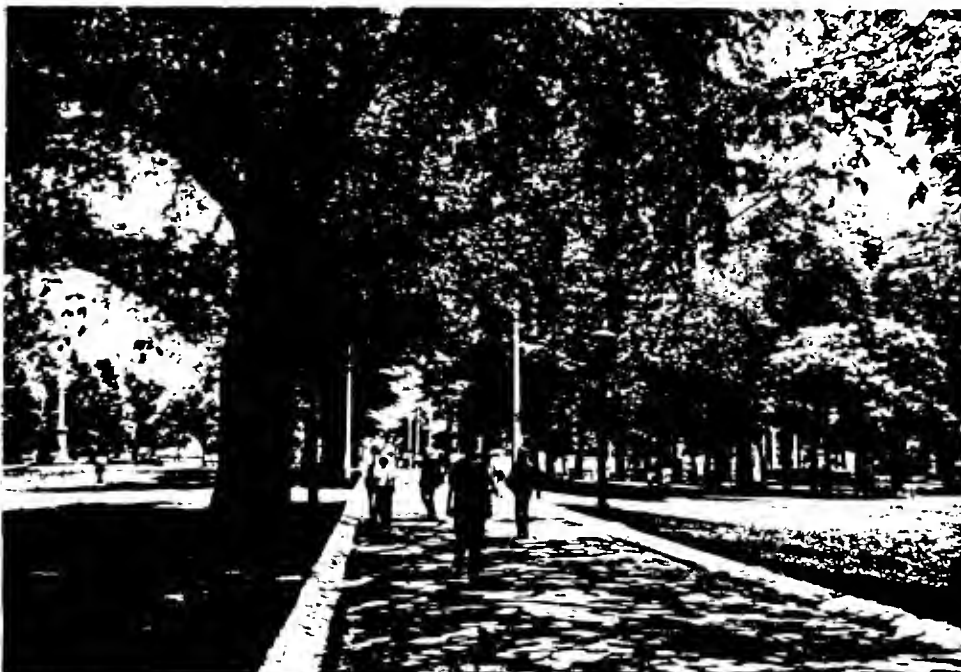
### Site Photograph 8

View through park-- a good example of general character of site-- full shade trees, green grass and sidewalks.

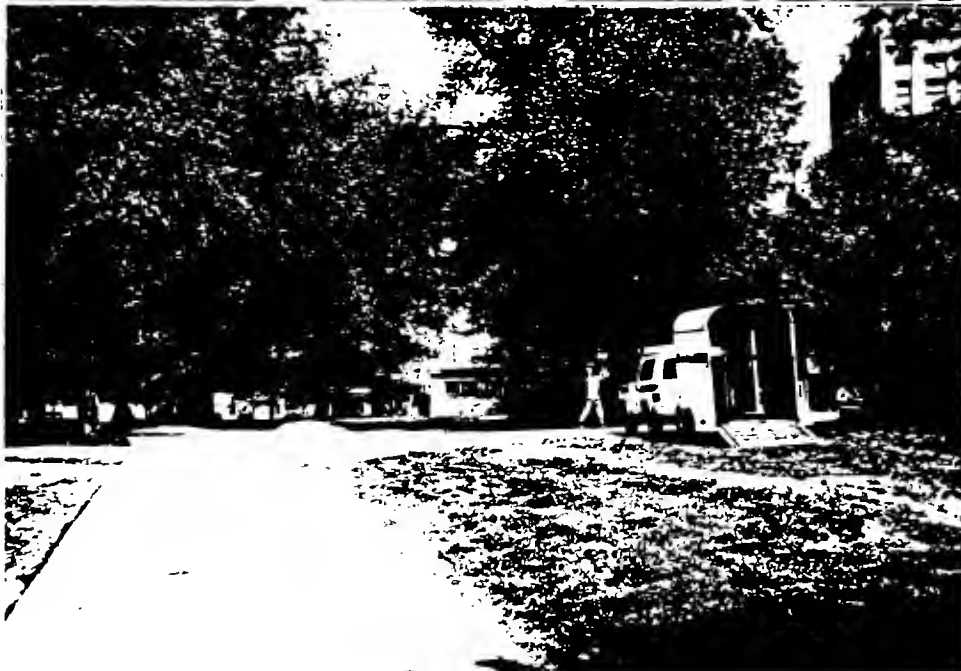
### Site Photograph 9

Vehicles should not park on grass.

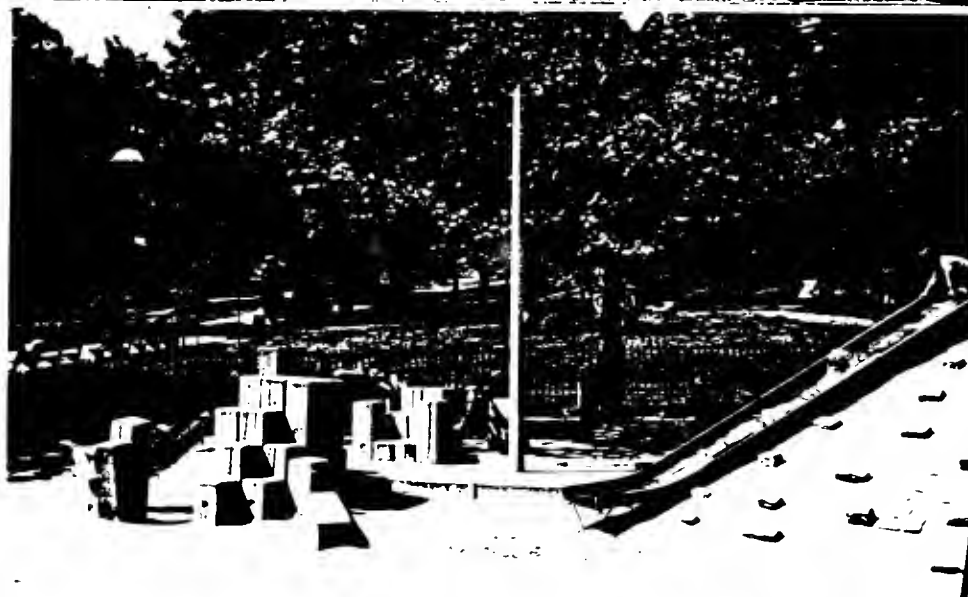
**Site Photograph 14**

Tot lot-- well  
maintained and well  
used.

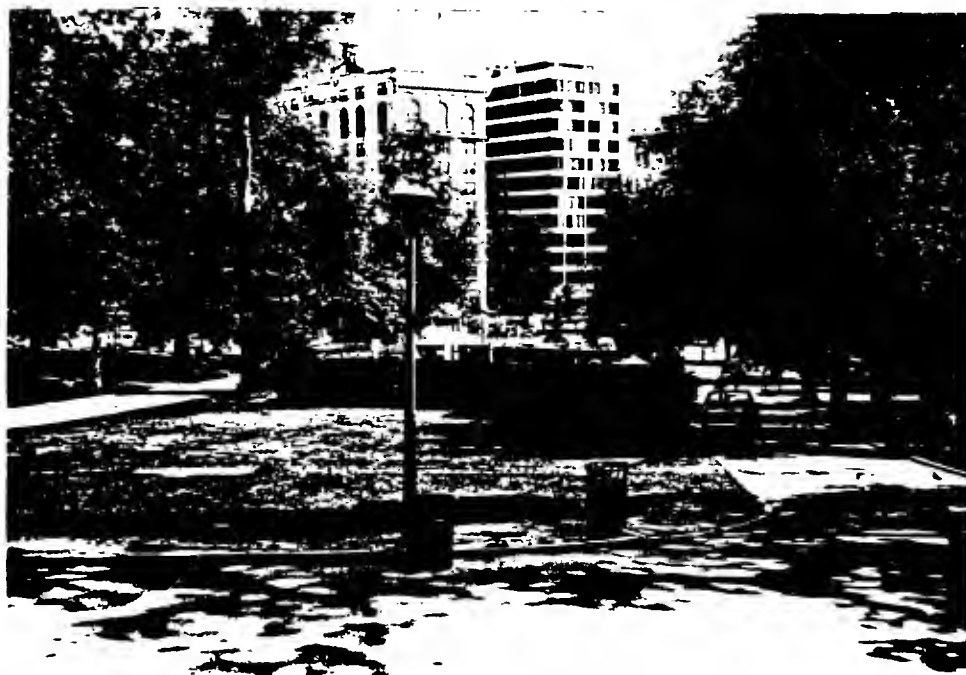
**Site Photograph 15**

View through site--  
shows temporary  
enclosure for  
construction.

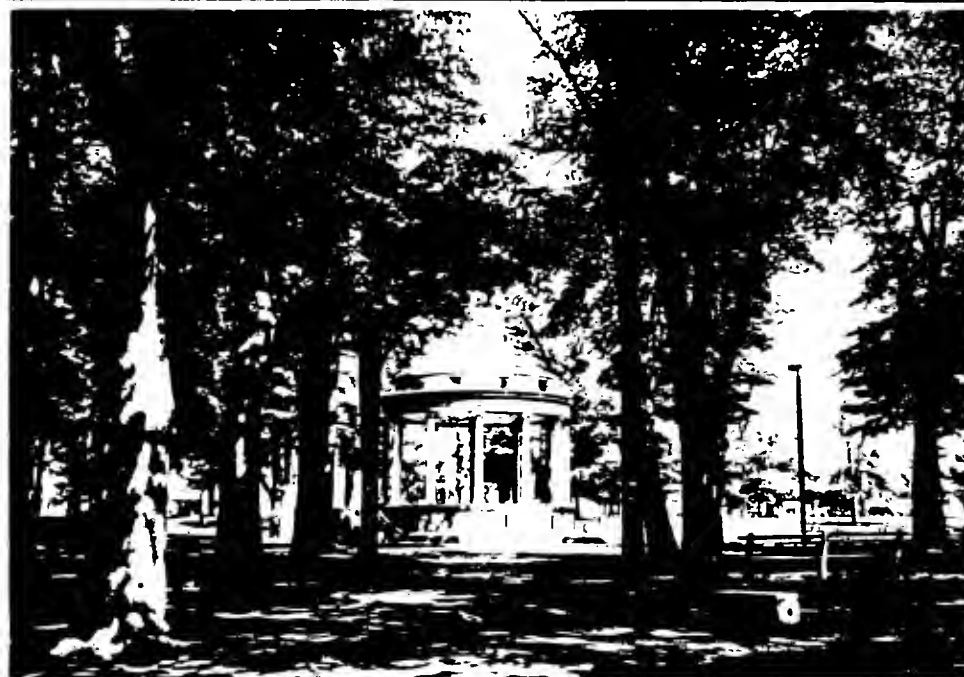
**Site Photograph 17**

Bandstand.

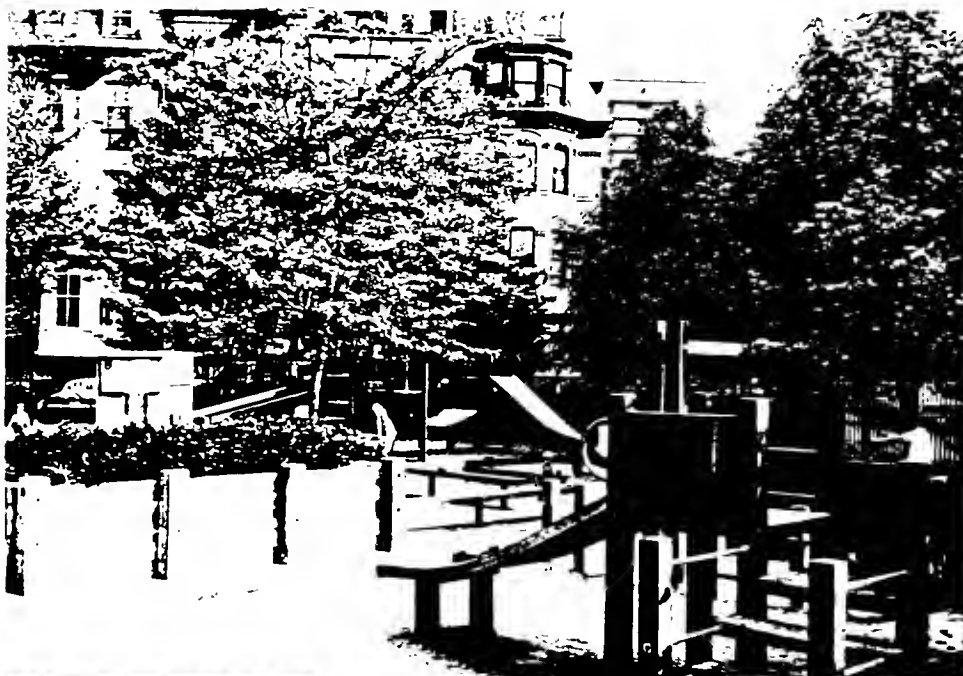
**Site Photograph 2**

View shows timber and  
metal play structures.  
Trees along fence  
define edge and provide  
shade.

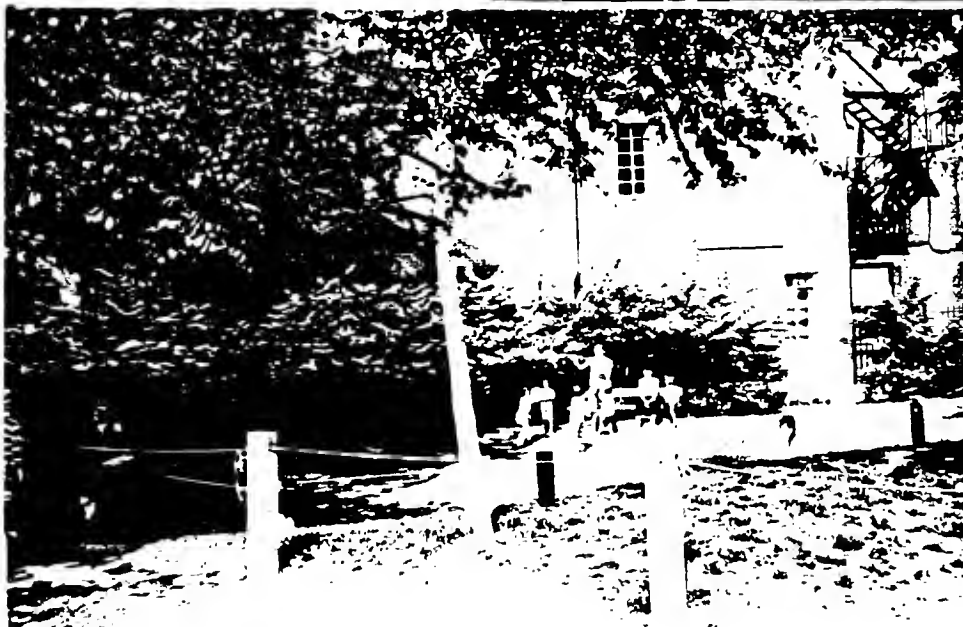
**Site Photograph 3**

Sunken free play area  
with flowering shrubs  
at base of wall.  
Grassed slope in  
foreground with  
Birch trees.

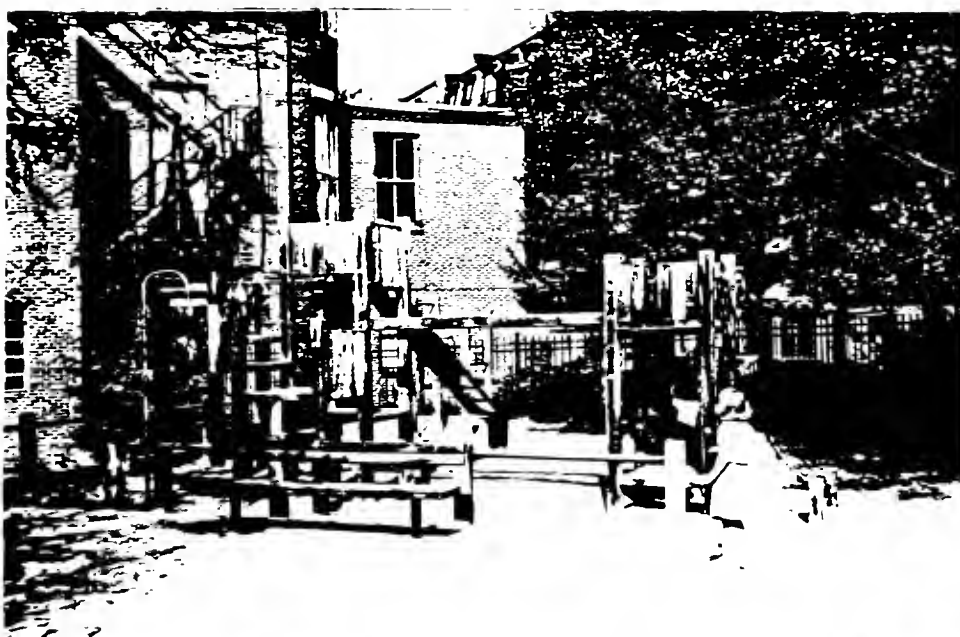
#### Site Photograph 4

Timber and metal  
play structures.

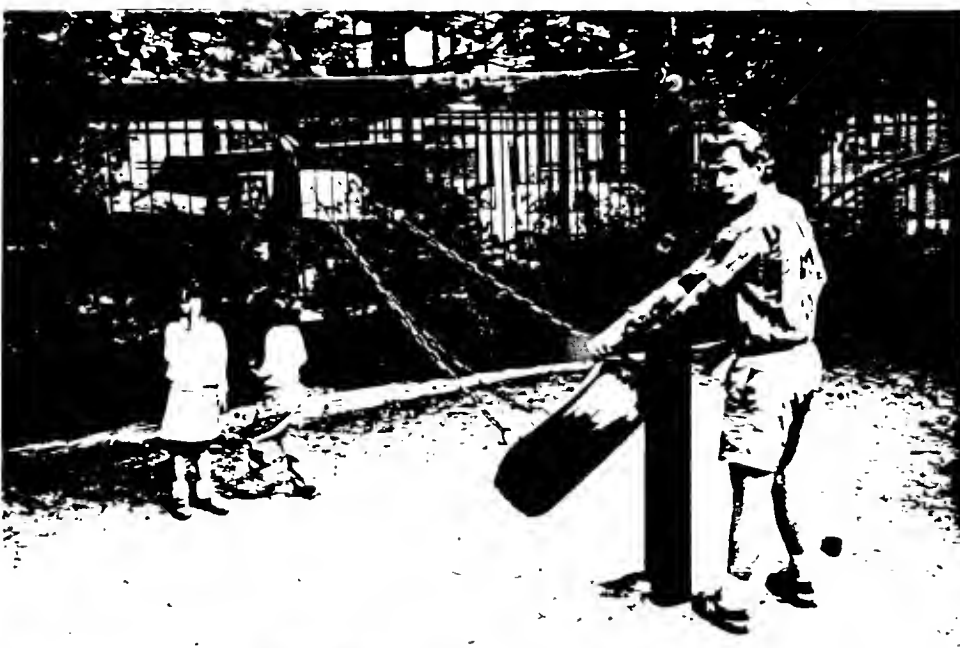
#### Site Photograph 5

Illustrates how close  
tire swings are to  
support post.

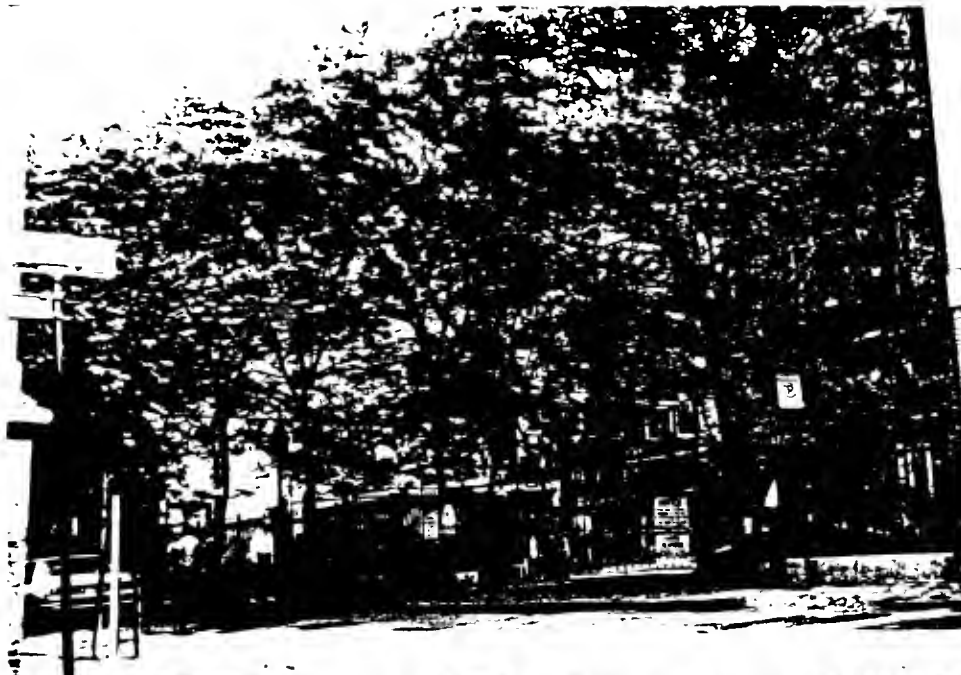
**Site Photograph 1**

View into the park from across street. Shows steel picket fence around edge with indentation at entrance. Honeylocust provide tall canopy of filtered shade.

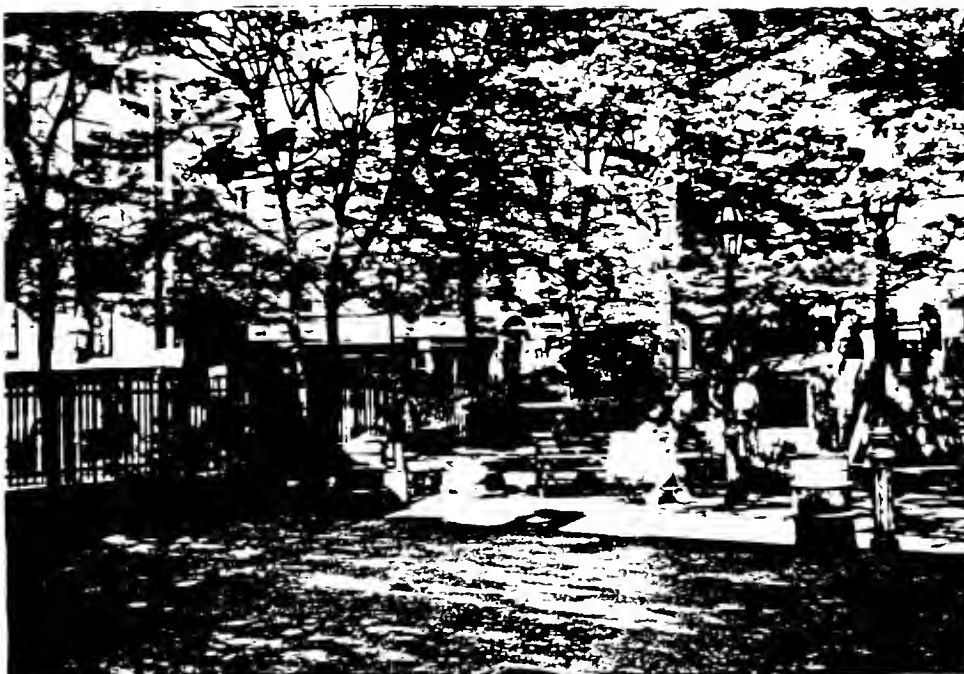
**Site Photograph 4**

Raised sitting area  
with planted area  
behind.

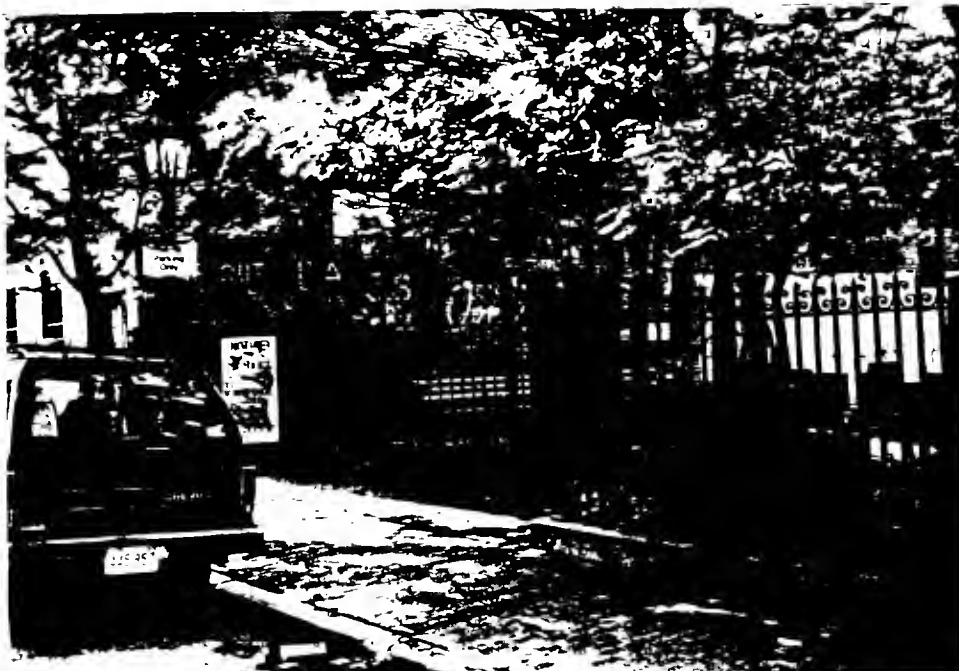
### Site Photograph 1

Park front edged with decorative metal fence with plant bed behind entrance indented.

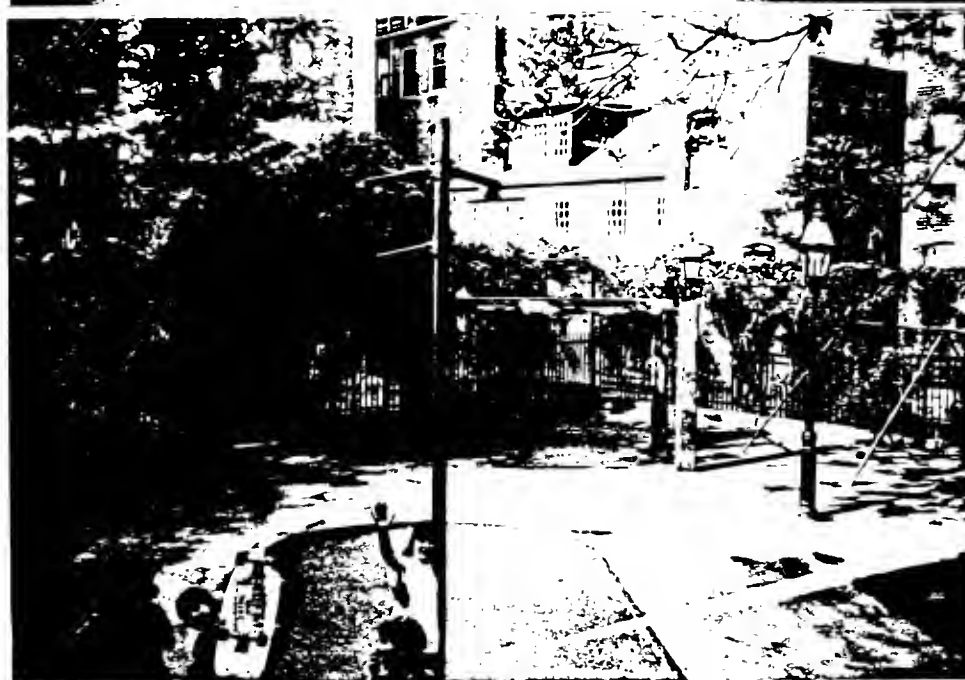
**Site Photograph 6**

View from upper level.  
Wisteria from  
neighboring property  
enhancing park edge.

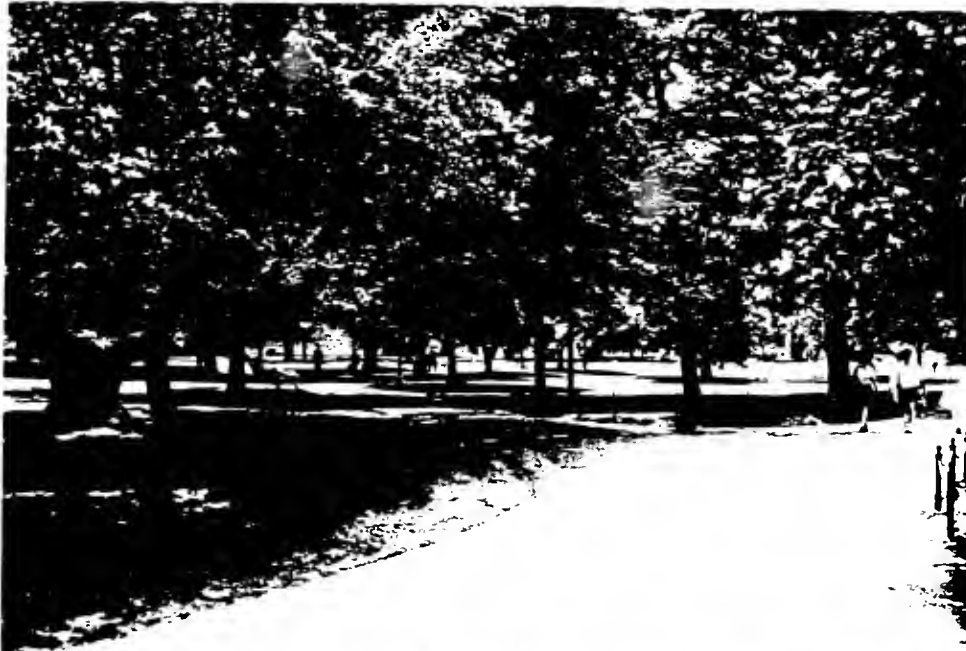
### Site Photograph 1

View from entrance into park. At left, grass eroded by foot traffic. At right, post and chain-- very effective at keeping people off grass.

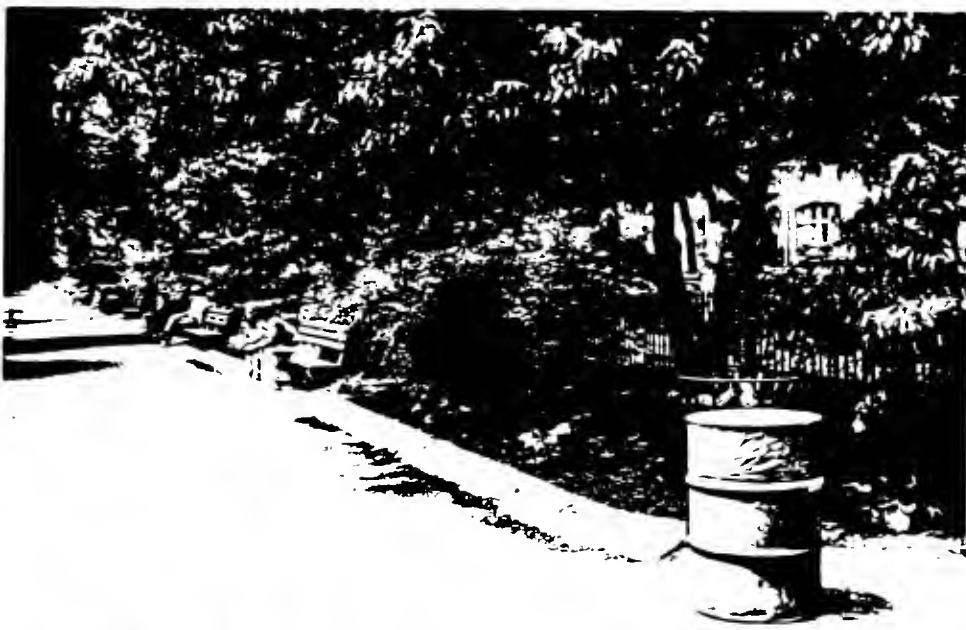
### Site Photograph 2

Shrub and ornamental plant beds along edge of park. Cobble edge protects planting beds.

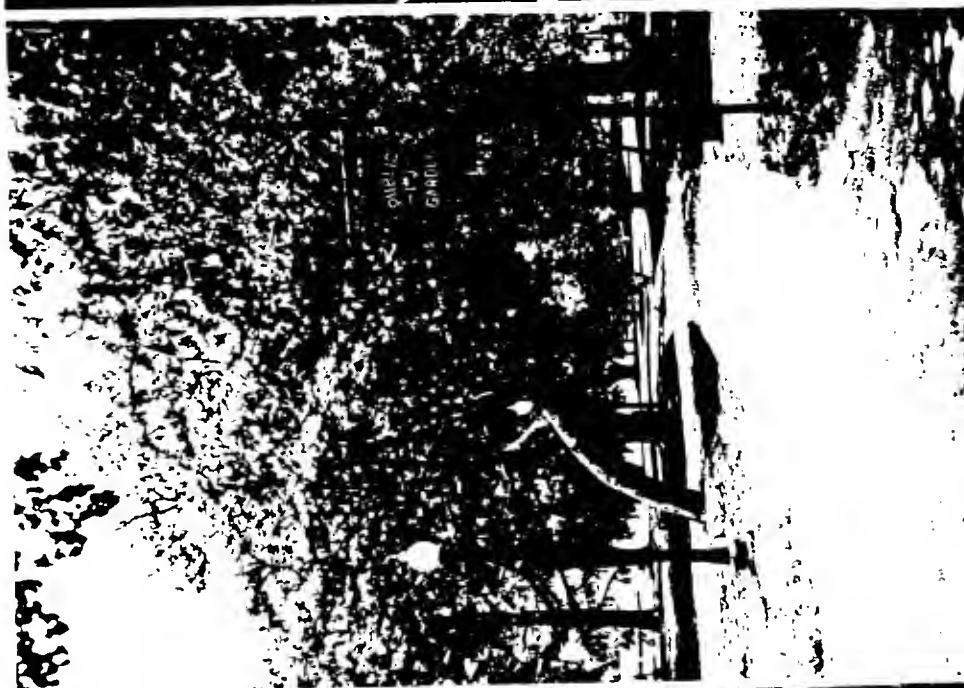
**Site Photograph 5**

Signage and lighting fixtures help to establish character of park.

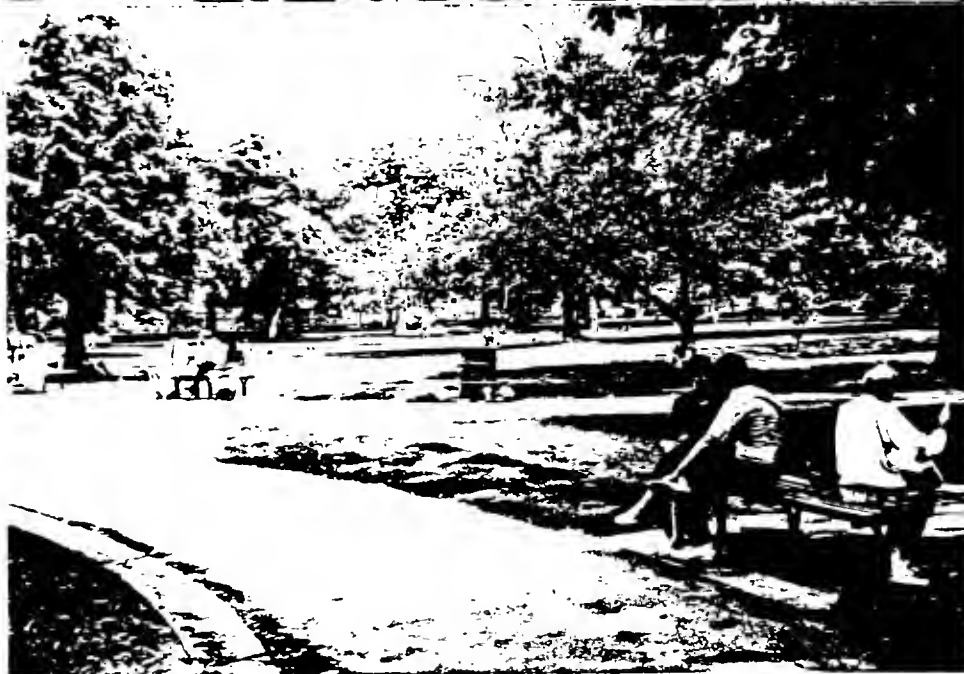
### Site Photograph 12

Trash build up around  
trash barrels.

On the whole, maintenance is very good, with the exception that trash needs more frequent removal from receptacles. The edging around the pond has settled in places and needs repair. Fountains are all in need of repair, and would add immeasurably to the park if in operation. The heavy use of the site is evident in desire lines and worn patches in the grass. Compacted dirt around trees will cause stress by denying water and oxygen intake of the roots.

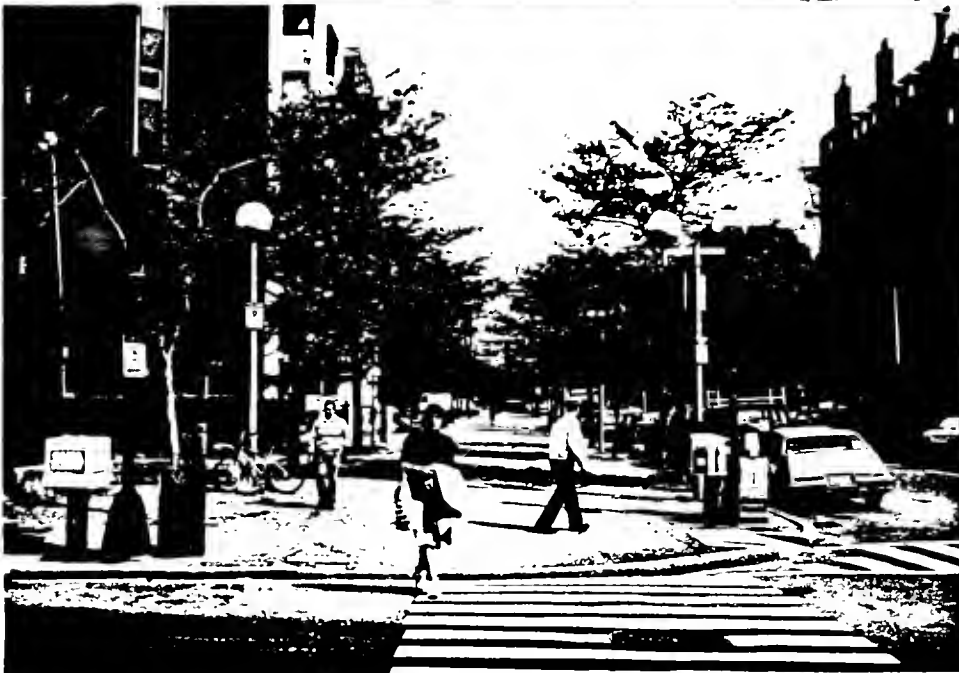
**Site Photograph 1**

View of block between Boylston and Newbury Streets. Note wide expanse of pavement in relationship to tree canopy. First tree on left typical condition of those to be removed - stunted and malformed.

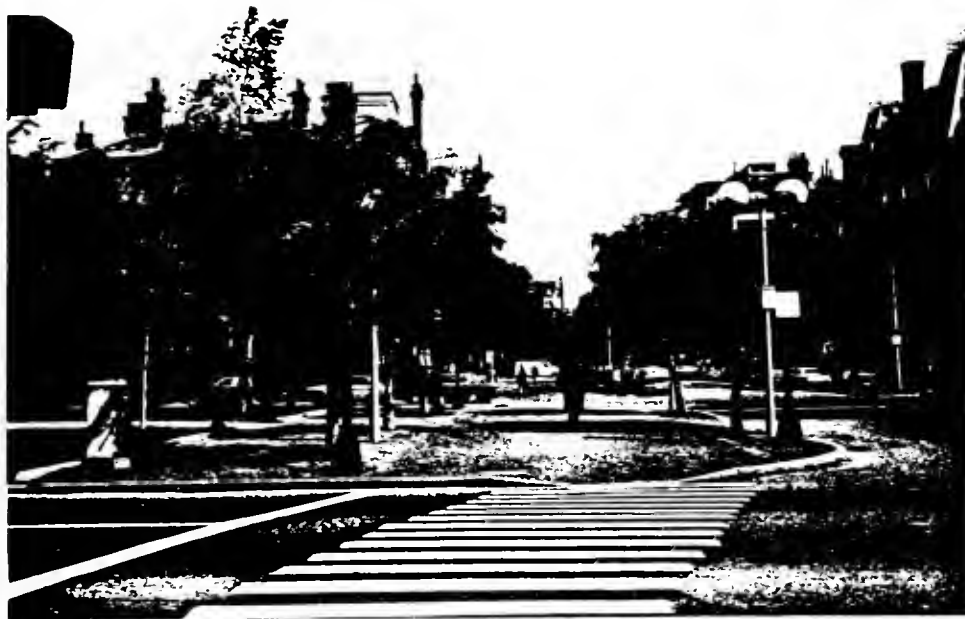
**Site Photograph 3**

View shows planting of annuals at base of trees. Flowers should be planted on a generous scale. Benches need re-alignment.

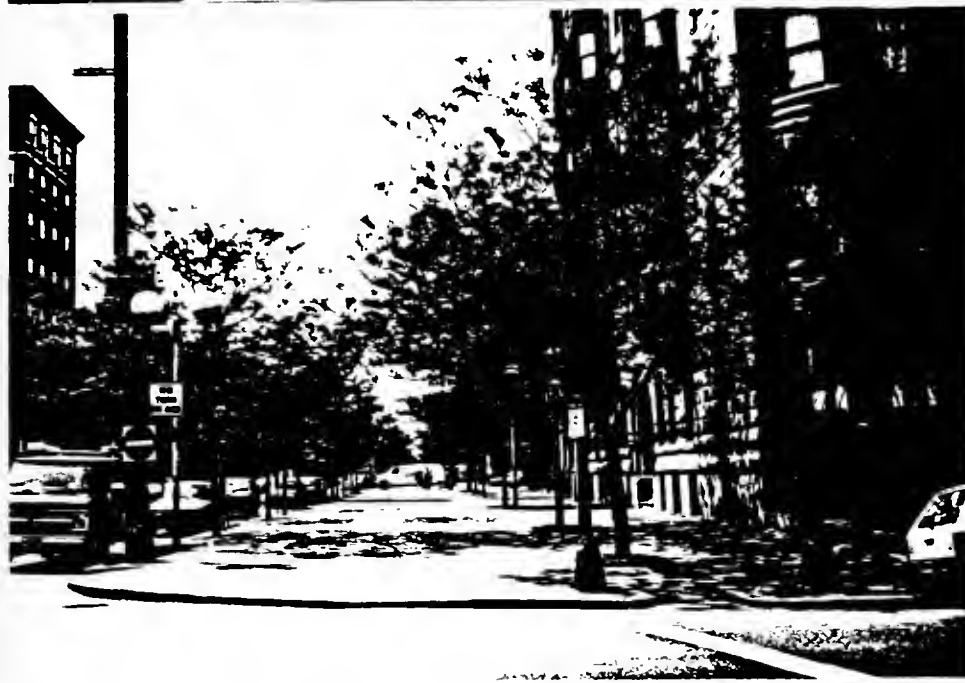
**Site Photograph 5**

View of corner at  
Beacon Street.
